REGION 6 EXECUTIVE SUMMARY

TOPIC: San Jacinto River Waste Pits Superfund Site

DATE: February 9, 2016

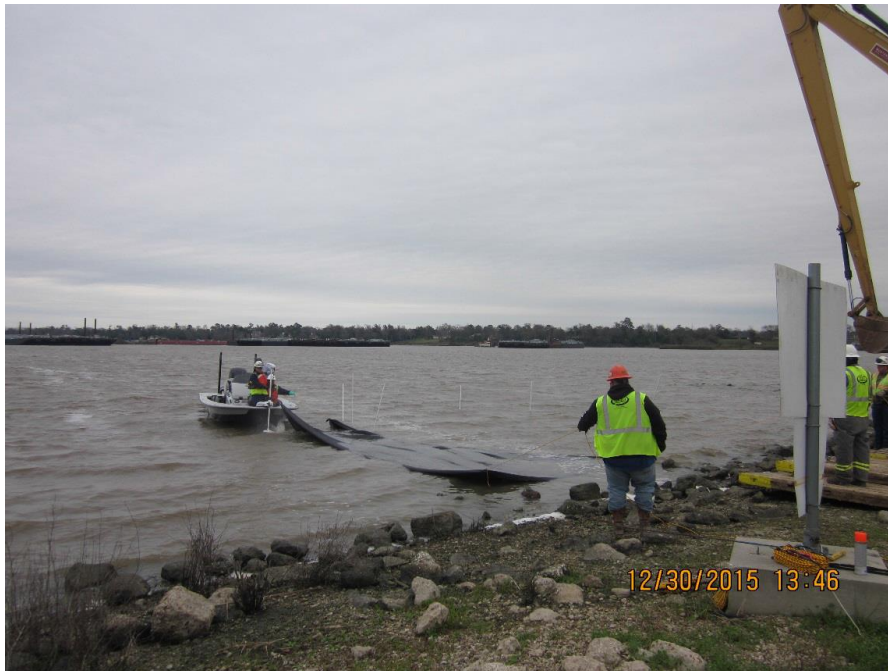
Placing geotextile over repair area.

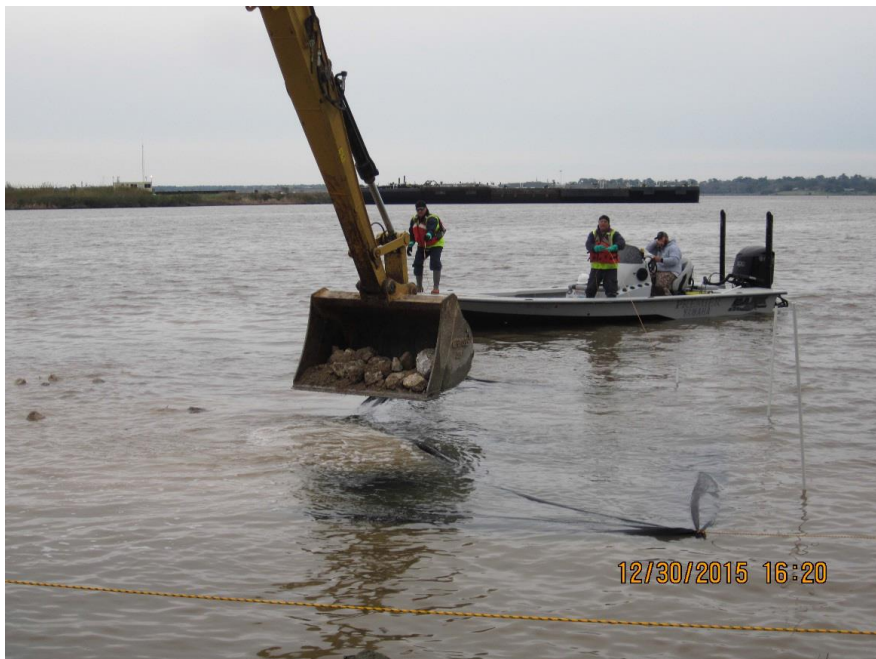
Placing Type C Rock (8" median diameter) on top of geotextile layer in repair area.
